USING TOLERANCE ANALYSIS SOFTWARE TO EXPLORE MANUFACTURING ALTERNATIVES

Product Marketing Manager – Sigmetrix

CASE STUDY – SPINNER COVER REDESIGN

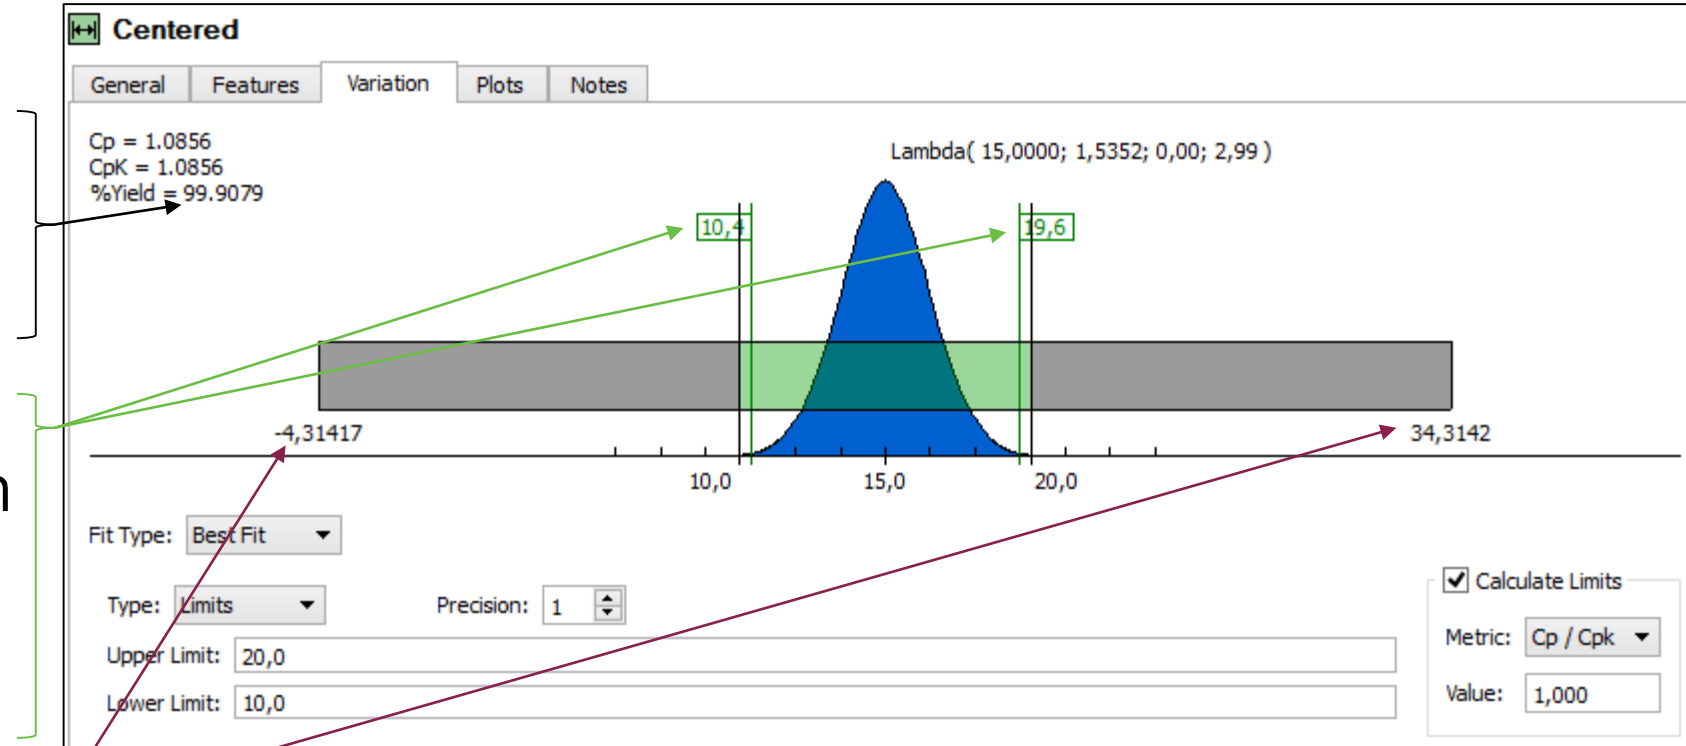
FIRST ANALYSIS OF GAP – DESIGN APPEARS ACCEPTABLE

Results:

- Design will achieve requirements of 10-20 mm 99.9% of the time
- Statistical variation is estimated to be between 10,4 and 19,6 mm, or $15 \pm 4,2$ mm, 99,7% of the time ($C_p=1$)
- Worst-case variation is between -4,3 and 34,3 mm or $15 \pm 19,3$ mm

Q: But why did the first assembly have interference (gap < 0)?

A: Clearances between bolt and holes not considered.

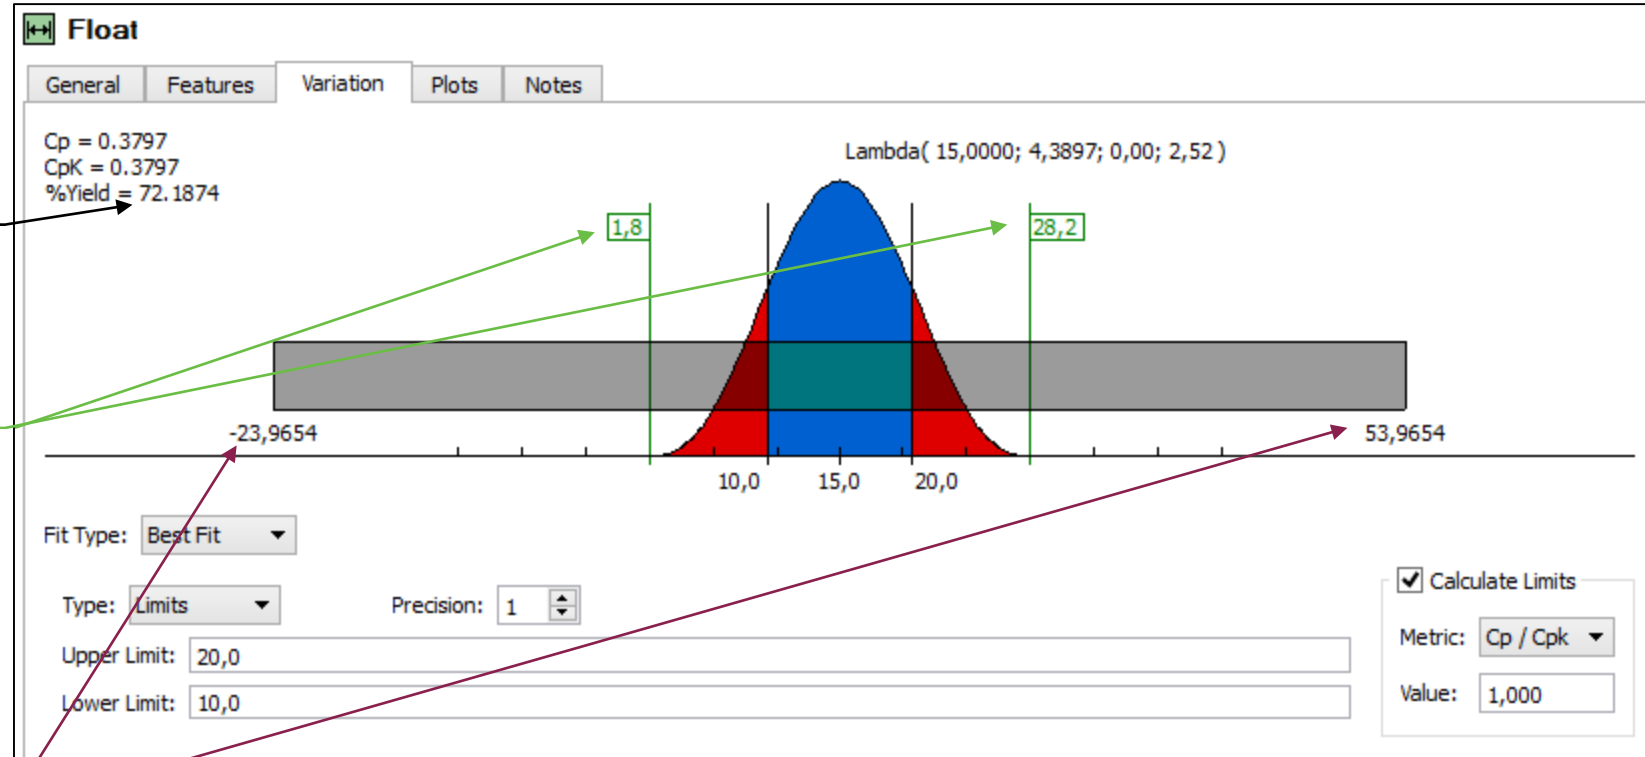
GAP ANALYSIS UPDATED WITH FLOAT OF BOLTED INTERFACES

Results:

- Design will achieve requirements of 10-20 mm 72.2% of the time
- Statistical variation is estimated to be between 1,8 and 28,2 mm, or $15 \pm 13,2$ mm, 99,7% of the time ($C_p=1$)
- Worst-case variation is between -24,0 and 54,0 mm or $15 \pm 39,0$ mm

Q: But why did the first assembly have interference (gap < 0)?

A: More investigation needed.

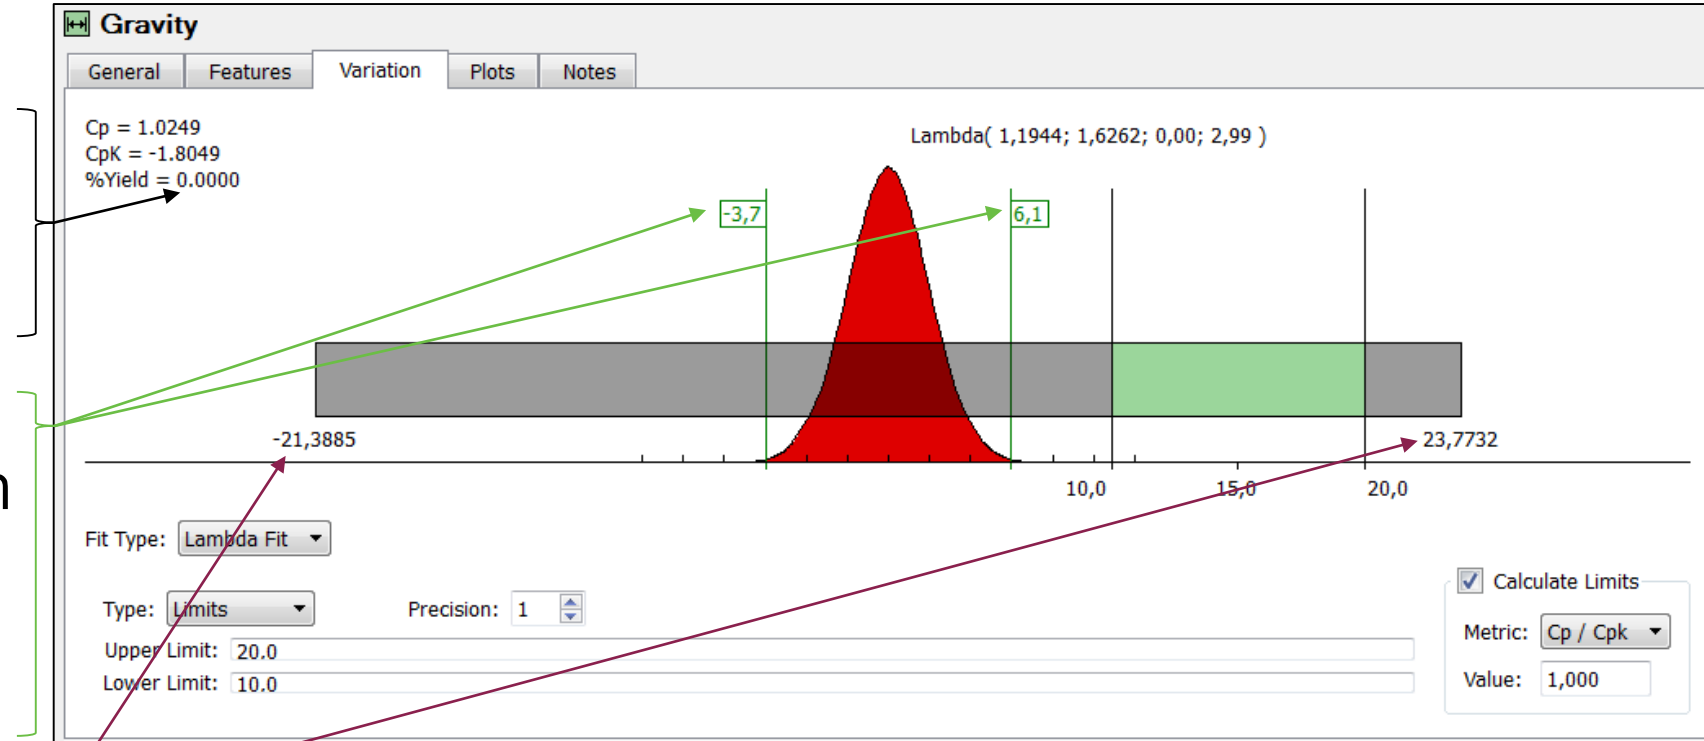
GAP ANALYSIS UPDATED WITH ASSEMBLY BIAS CONSIDERED

Results:

- Design will not achieve requirements of 10-20 mm
- Statistical variation is estimated to be between -3,7 and 6,1 mm, or $1,2 \pm 4,9$ mm, 99,7% of the time ($C_p=1$)
- Worst-case variation is between -21,3 and 23,8 mm or $1,2 \pm 22,6$ mm

Conclusion: Assembly technique is causing 13,8 mm bias in average gap leading to very high probability of interference!
