INFORMATION

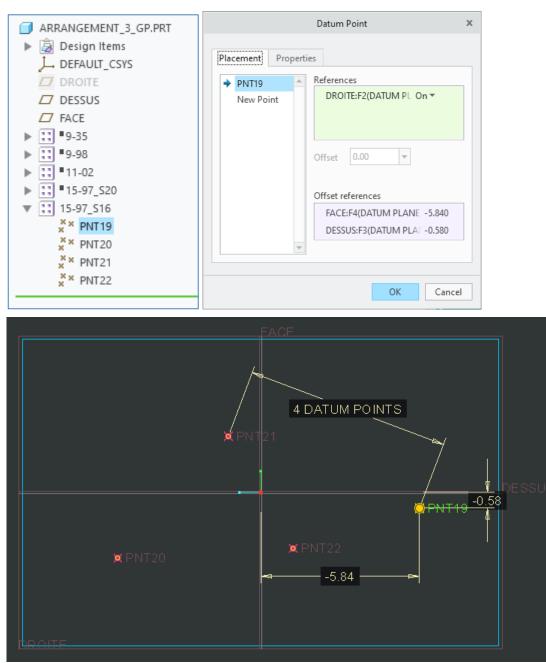
- I set DROITE view for above picture
- pattern leader is PNT19
- PNT19 is placed on DROITE and offset from FACE and DESSUS
- note that both dimesions have minus sign ... this is because PNT19 is located on gray side of datum
 planes ... see following picture explaining FACE sides
- you have to set enable_legacy_datum_planes yes in config.pro file to see both datum plane "lines" (brown and gray)
- you have to set show_dim_sign yes in config.pro file to see minus signs

- idx 2 ... PNT20 ... correct position
- idx 3 ... PNT21 ... correct position
- idx 4 ... PNT22 ... correct position
- it seems to me that point order is not correct

It seems to me that you created the pattern incorrectly.
